## **Inlay Expansion Joint Covers.**

Thanks for the enquiry, I thought we should make you aware of some of the issues with inlay joints that have silicon or mastic type inserts in the cover plate. The following pictures show some of the problems that can occur with minimal movement.

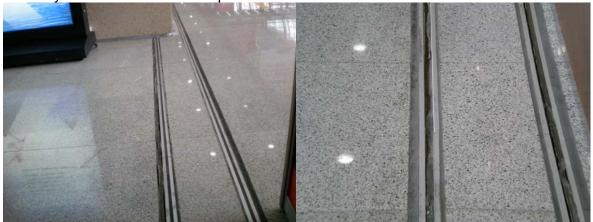
Mastic has disappeared eventually the recess will fill with dirt and debris and thermal expansion of the structure is likely to cause the cover to rip off.

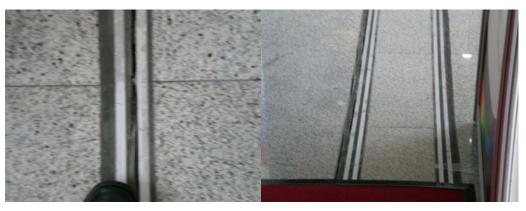
These pictures shows the sealant failing badly under minimal movement, causing trip hazards, hygiene issues.

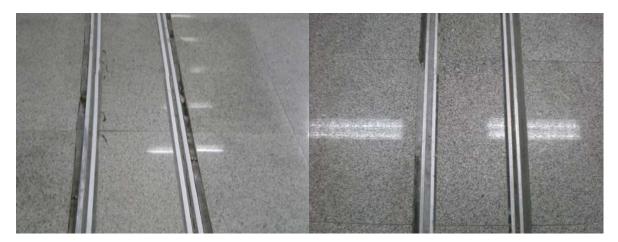
The following pictures show where the sealant has been depressed by foot traffic causing it to de-bond, this will also cause issues overtime and will eventually cause the cover plate to lift.

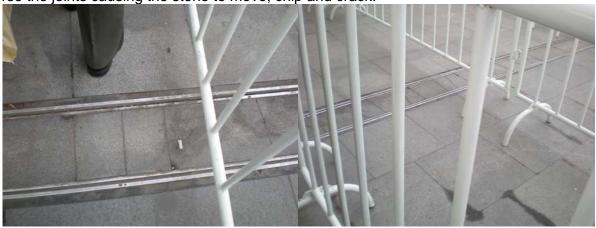
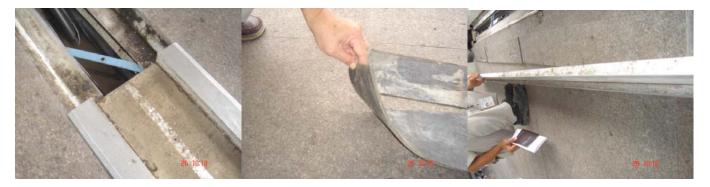
The final images shows extreme damage to the paving, this is caused general by the cover plate being to thin for the application and deflection occurring, also it is unlikely a suitable high strength non shrink epoxy bedding compound has been used under the expansion joint cover. In the second lot of photo's

you will see our PAVA Series, where the stone has also cracked, investigations revealed that the stone inlay was not held in please with epoxy as recommended but in fact the inlay was loosely inserted into the tray on top of a foam bedding compound to get the material to finish at the desired height. In this application (Airport), trolley and various shapes and sizes, golf carts and even vehicles continually

transverse the joints causing the stone to move, chip and crack.

For these reason and in-particular the problems associated with the sealant or mastic style applications, Latham's have developed the new PAVA and SGAL inlay joints, the newest in the range offers tremendous day to day movement, without de-bonding, sinking of the infill and areas for debris build up offering far better maintenance free results for the client.

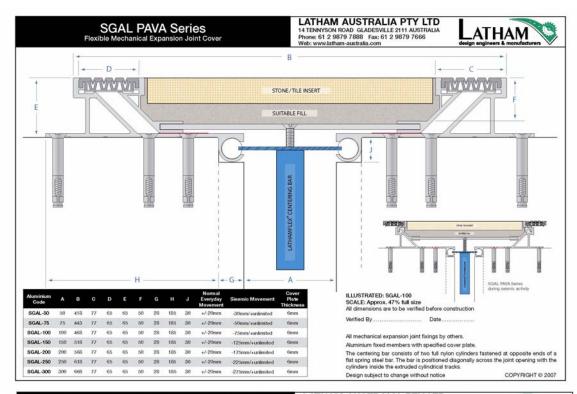
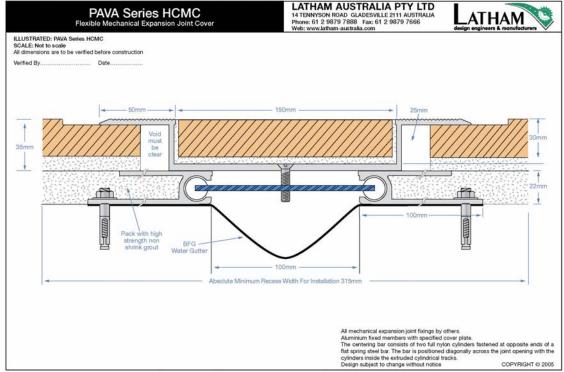
Both the Latham details that follow address this issue, which is generally caused by the fact the structural expansion joint covers are move more that a sealant type joint will allow causing bond failure, this combined with the problems associated with the sealant depressing over time and causing trip hazards and unsightly dirt traps, has prompted Latham to offer their PAVA Series.

See the following details, contact your Latham representative or authorized agent for further detailed information.
